## **Composite Failure Analysis Handbook Update #1**

*Greg Walker*

*Boeing Defense & Space Group*

**April 1995**

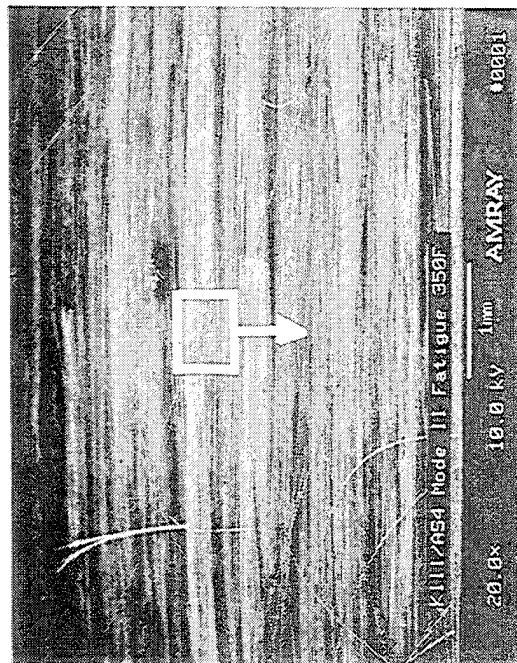
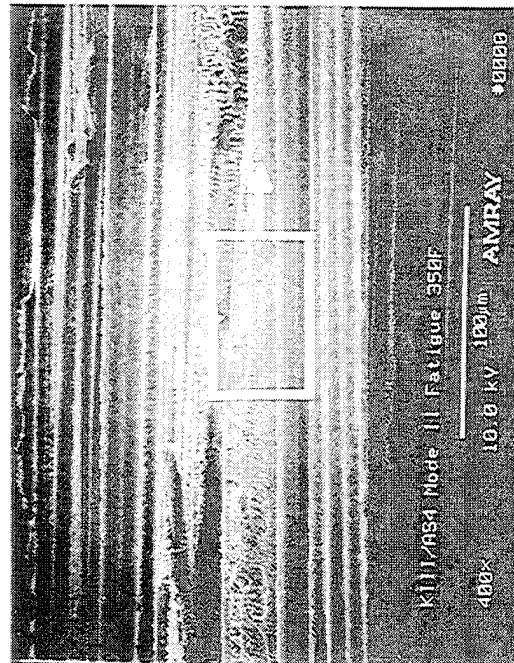
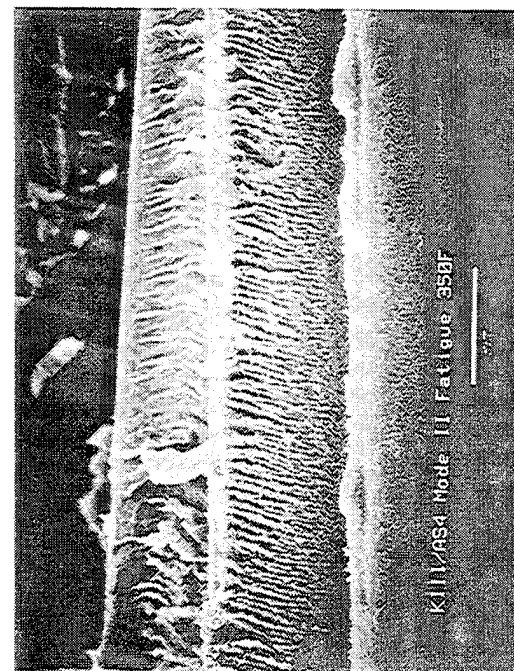
Examination of the fracture surfaces did not reveal any definite indications of fatigue, except for a feature that may be related to the cyclic loading. This feature appeared to be typical of a mode II hackle. However, when observed at high magnification the feature appears to be wider and thinner than similar hackles on statically loaded specimens. This feature was observed both on the RT specimen (Figures 3.2-15 and 3.2-16) and the 350°F tested specimens (Figures 3.2-17 and 3.2-18).

Figure 3.2-18. SEM Fractographs of a KIII/AS4 Interlaminar Mode II (Shear) Fatigue Fracture Surface, 350° F

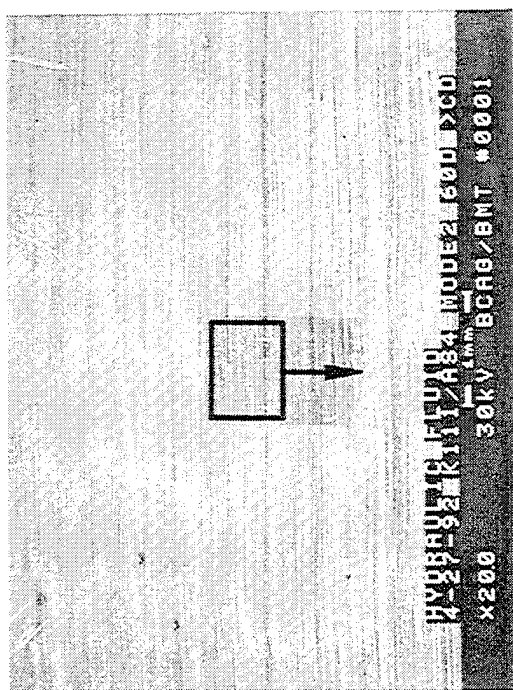
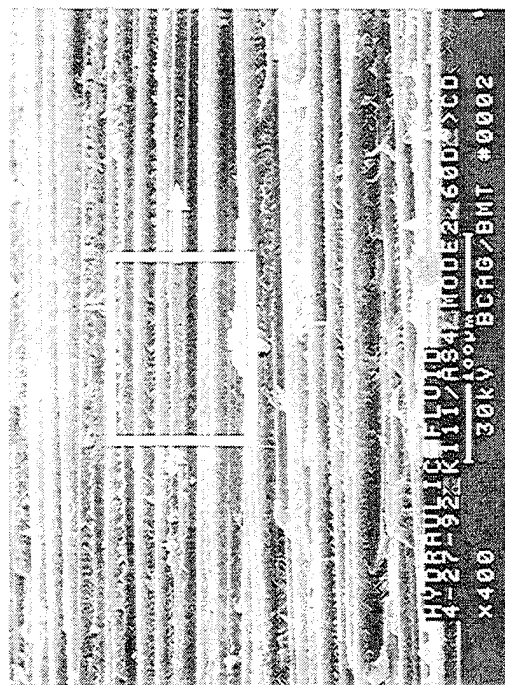
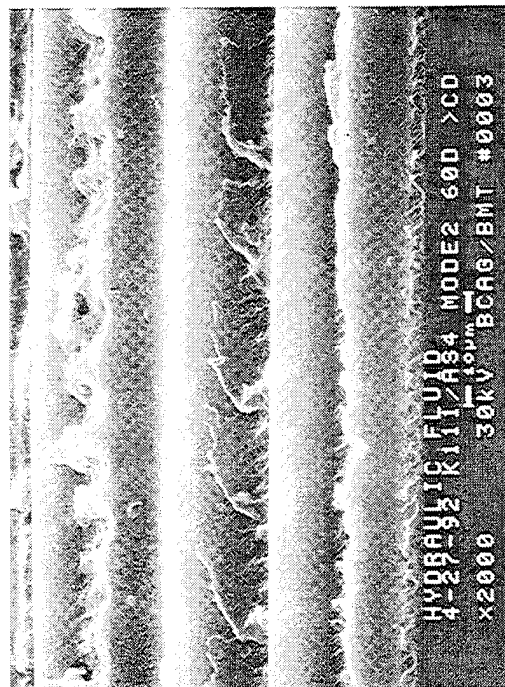
Figure 3.2-19. SEM Fractographs of a K111/A84 Interlaminar Mode II Shear Fracture Surface Exposed to Hydraulic Fluid for 7 Days

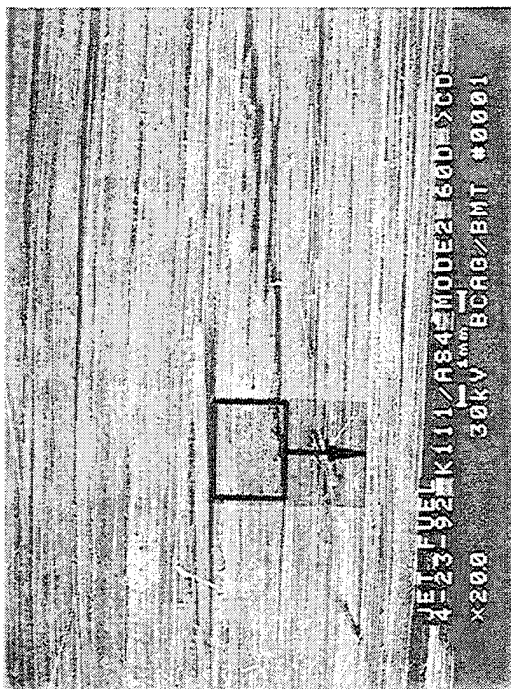
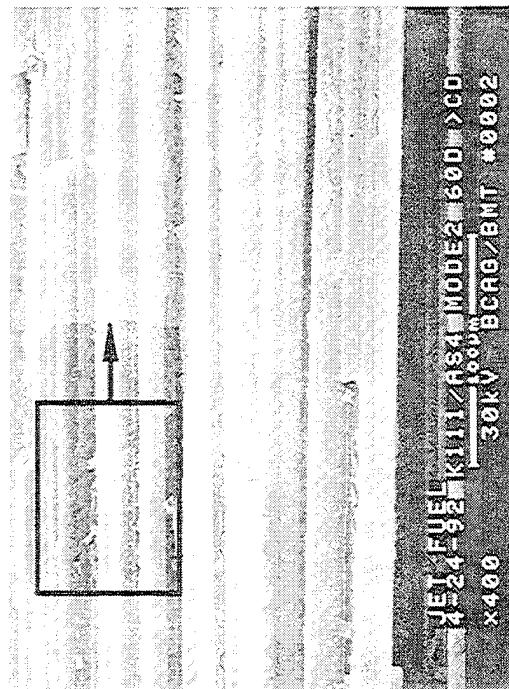
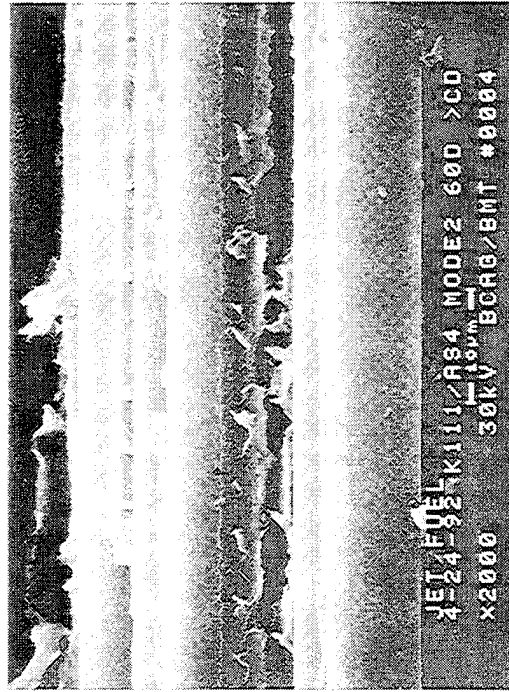
Figure 3.2-20. SEM Fractographs of a K111/AS4 Interlaminar Mode II Shear Fracture Surface Exposed to JP4 Jet Fuel for 7 Days

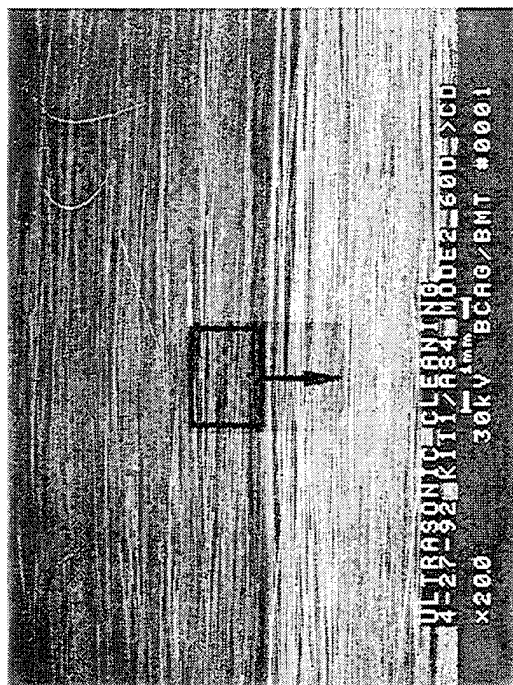
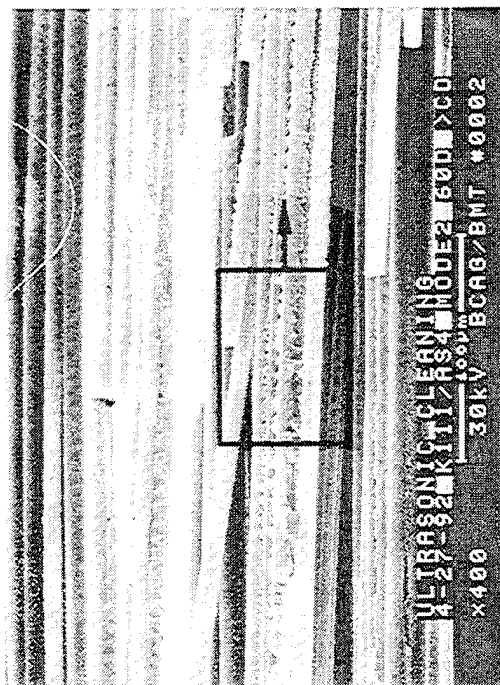
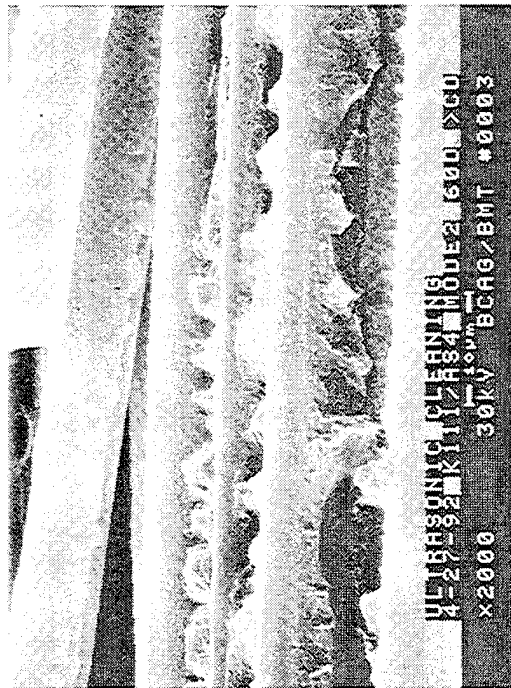
Figure 3.2-21. SEM Fractographs of a KIII/AS4 Interlaminar Mode II Shear Fracture Surface Exposed to Ultrasonic Agitation in Distilled Water for 24 Hours

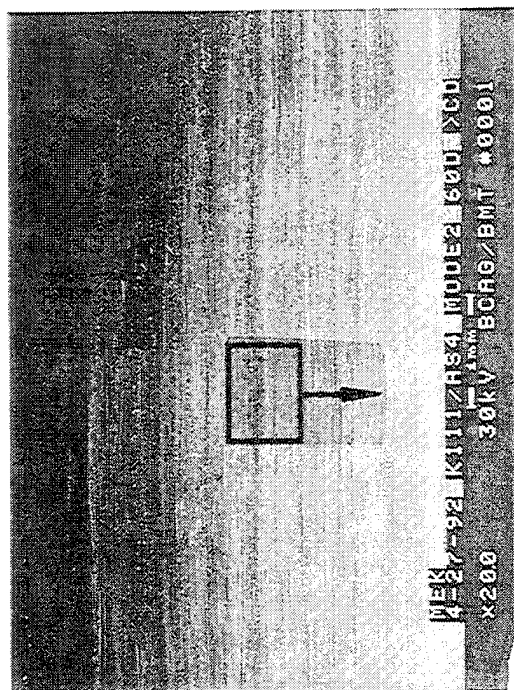
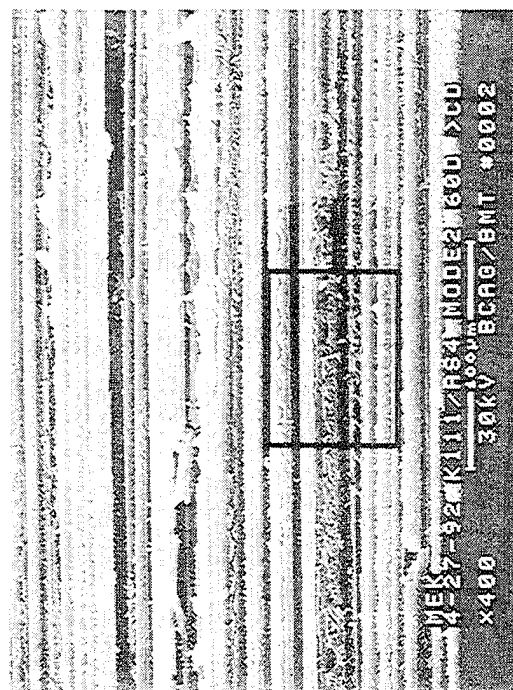
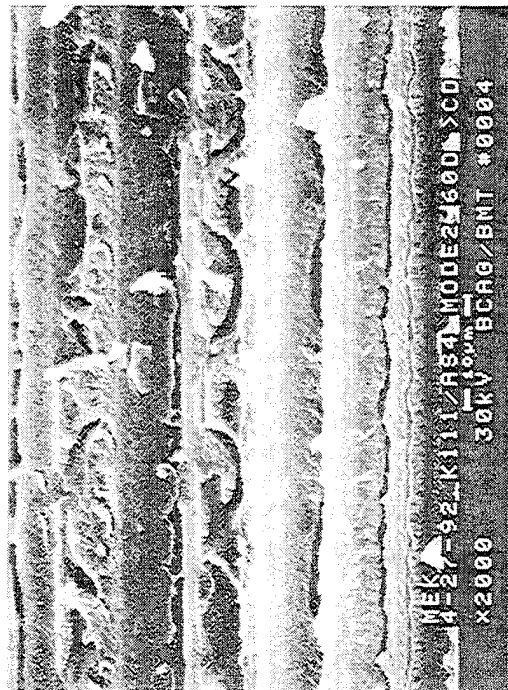
Figure 3.2-22. SEM Fractographs of a K111/AS4 Interlaminar Mode II Shear Fracture Surface Exposed to MEK for 24 Hours

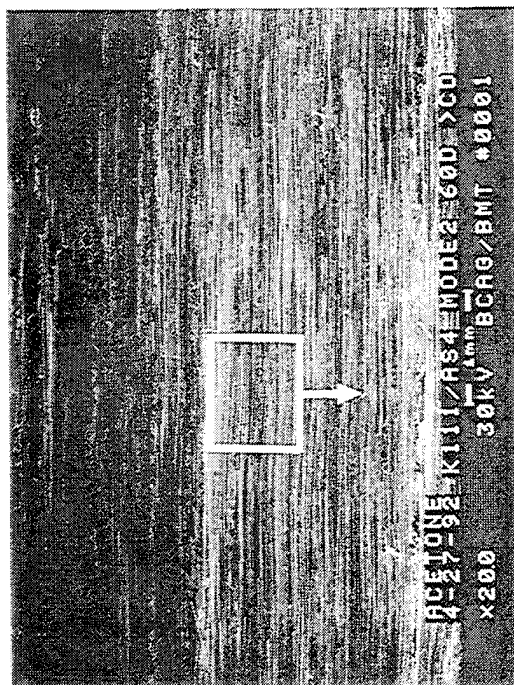
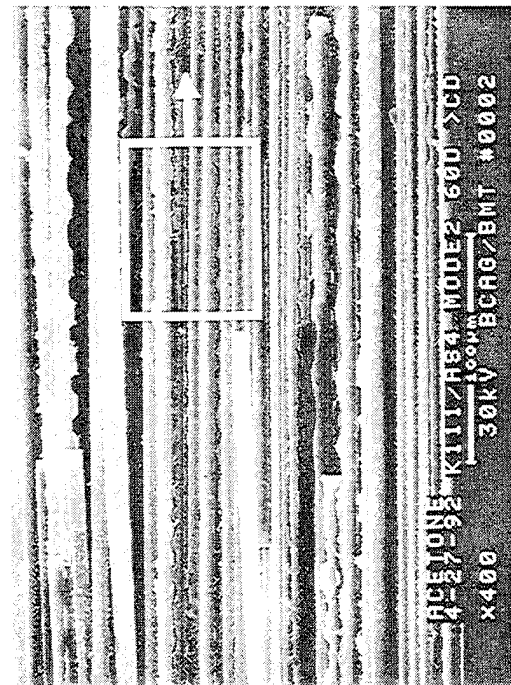
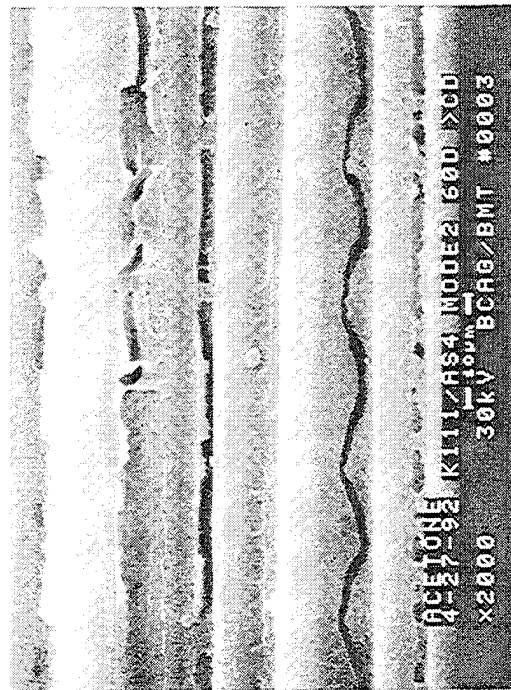
Figure 3.2-23. SEM Fractographs of a K111/AS4 Interlaminar Mode II Shear Fracture Surface Exposed to Acetone for 24 Hours

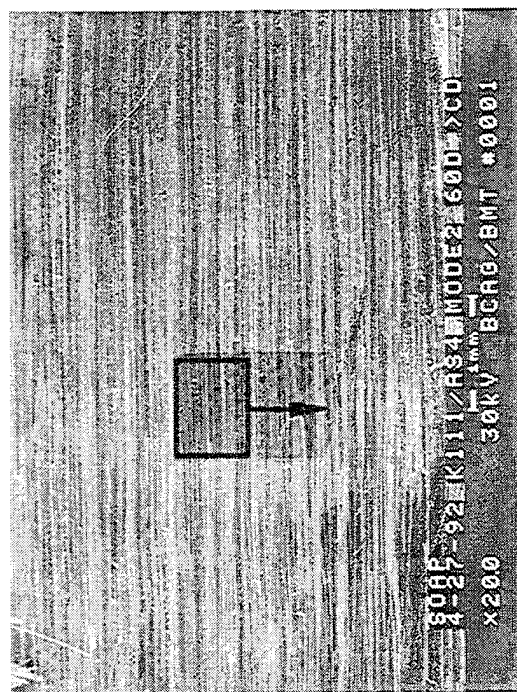
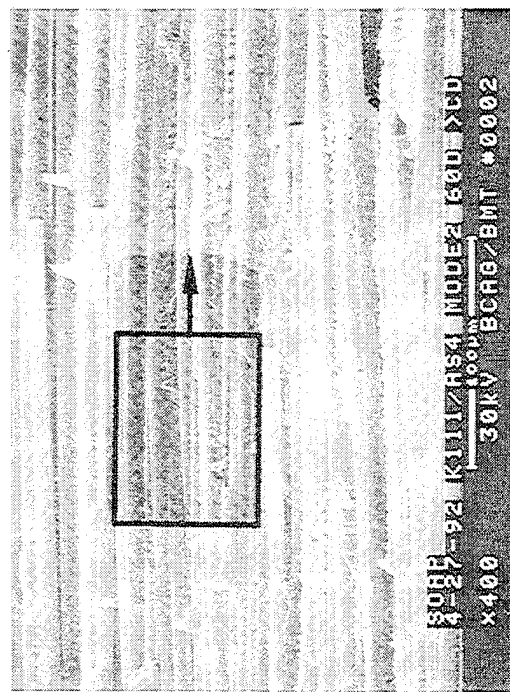
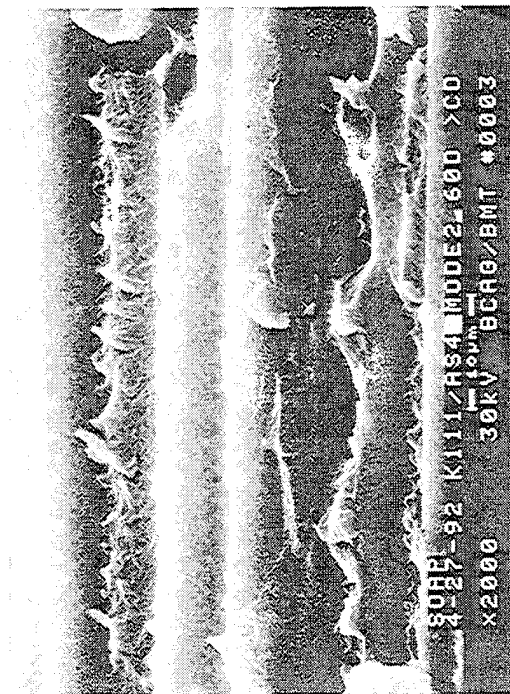
Figure 3.2-24. SEM Fractographs of a K111/AS4 Interlaminar Mode II Shear Fracture Surface Exposed to Soap Solution for 24 Hours

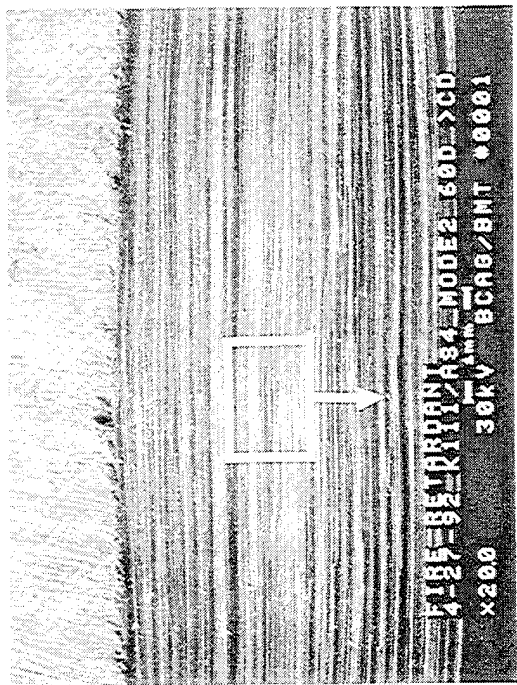
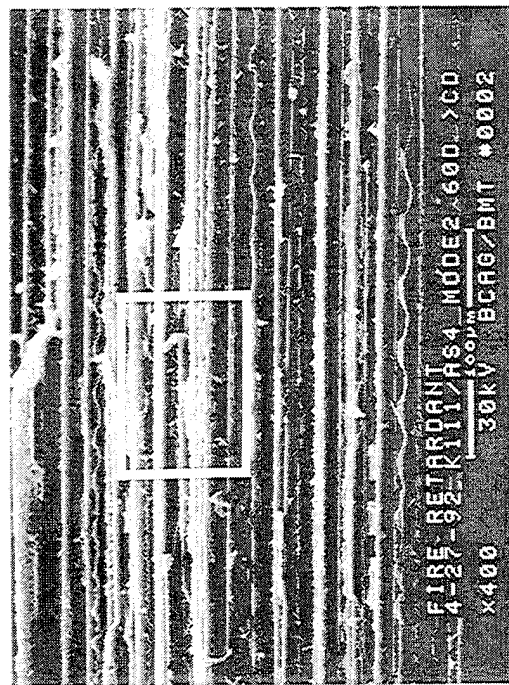
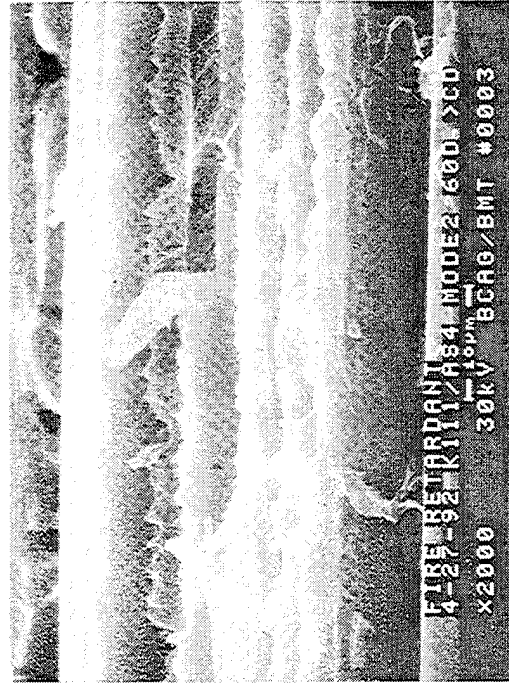
Figure 3.2-25. SEM Fractographs of a K11/AS4 Interlaminar Mode II Shear Fracture Surface Exposed to Fire Retardant Foam for 7 Days

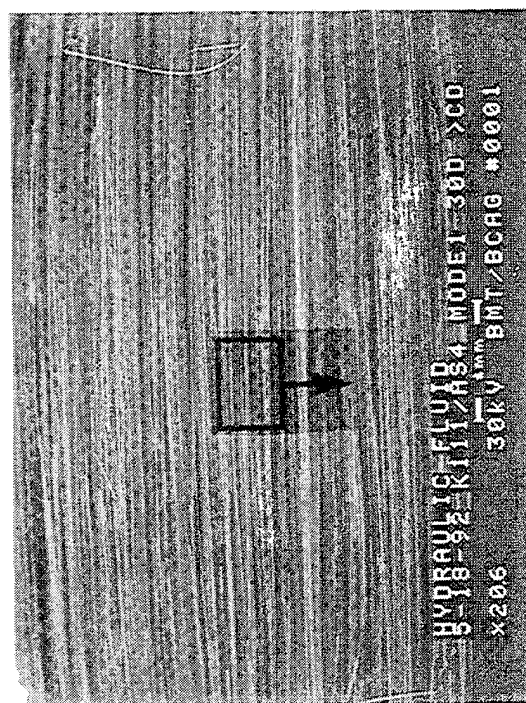
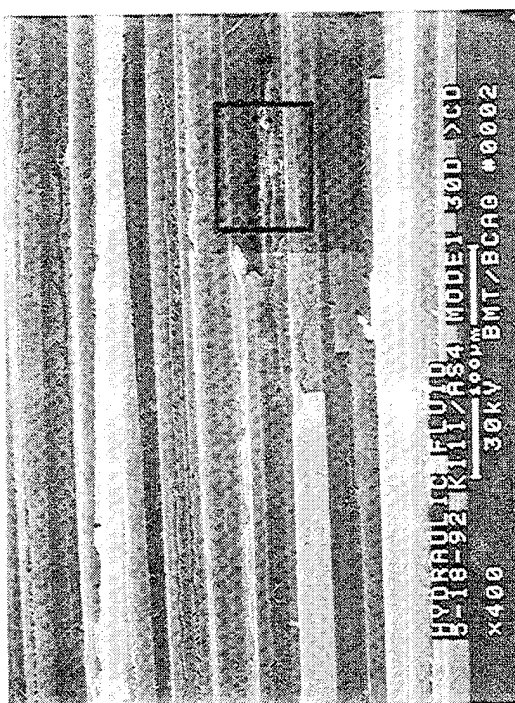
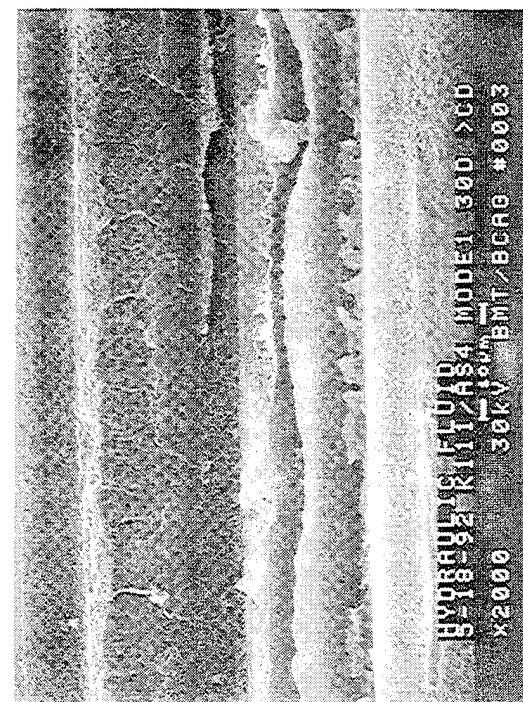
None of the exposure conditions appeared to have degraded the fracture features (Figure 3.2-26 through Figure 3.2-32).

Figure 3.2-26. SEM Fractographs of a K11/AS4 Interlaminar Mode I Tension Fracture Surface Exposed to Hydraulic Fluid for 7 Days

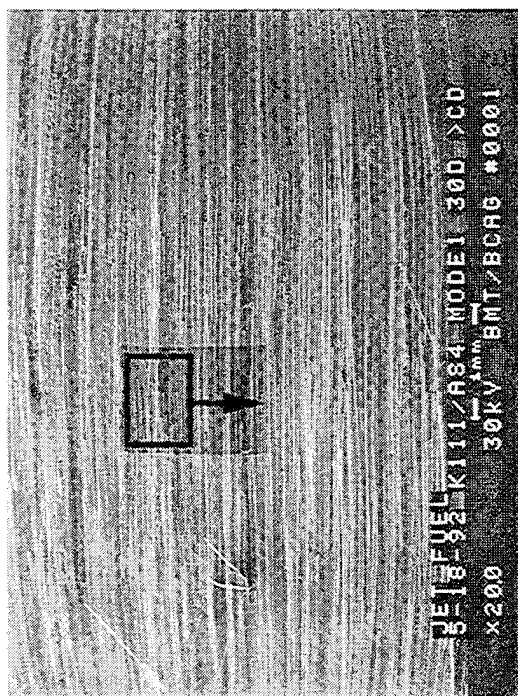
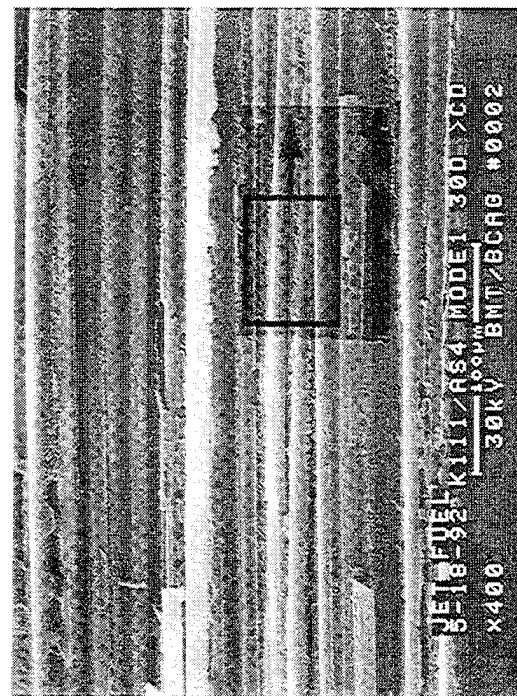
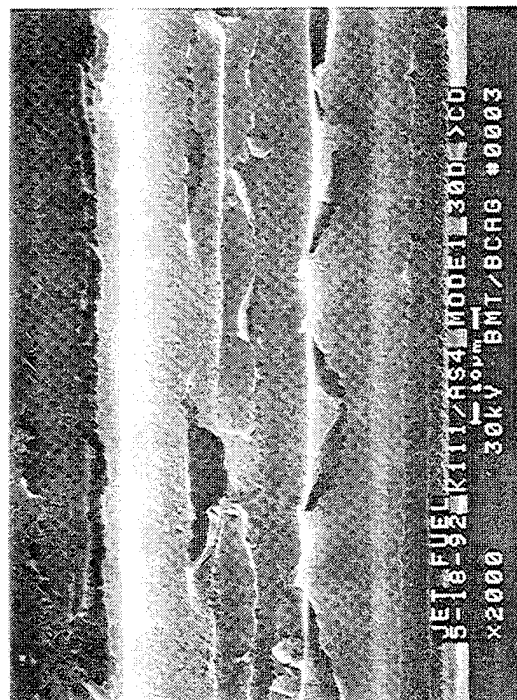
Figure 3.2-27. SEM Fractographs of a K111AS4 Interlaminar Mode I Tension Fracture Surface Exposed to JP4 Jet Fuel for 7 Days

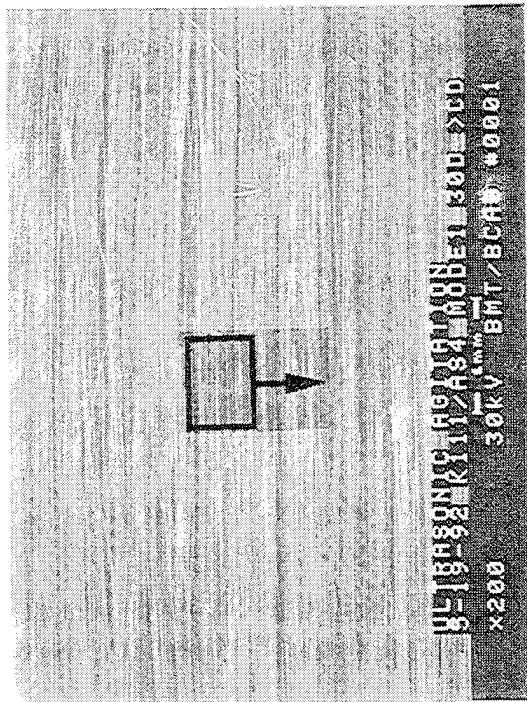
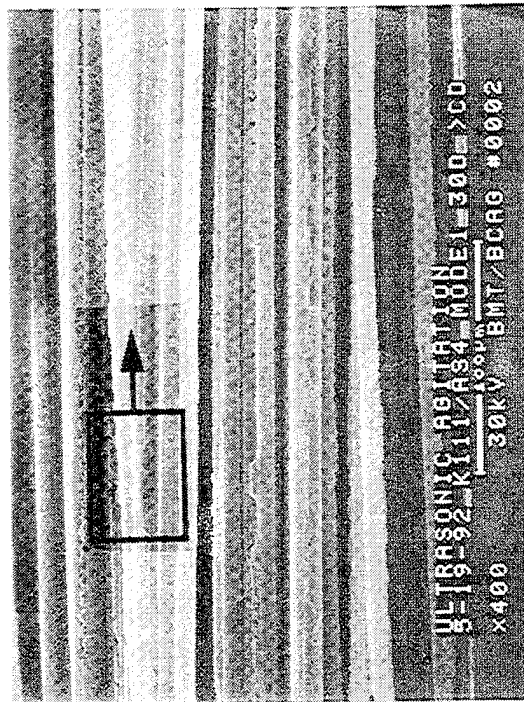
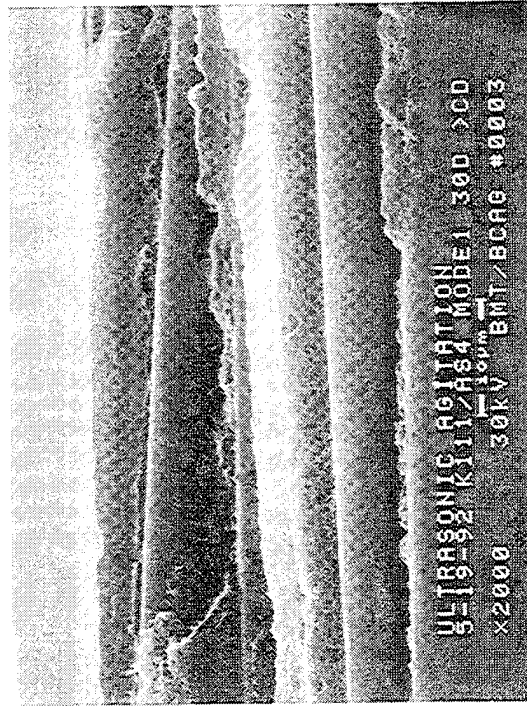
Figure 3.2-28. SEM Fractographs of a K111/AS4 Interlaminar Mode I Tension Fracture Surface Exposed to Ultrasonic Agitation in Distilled Water for 24 hours

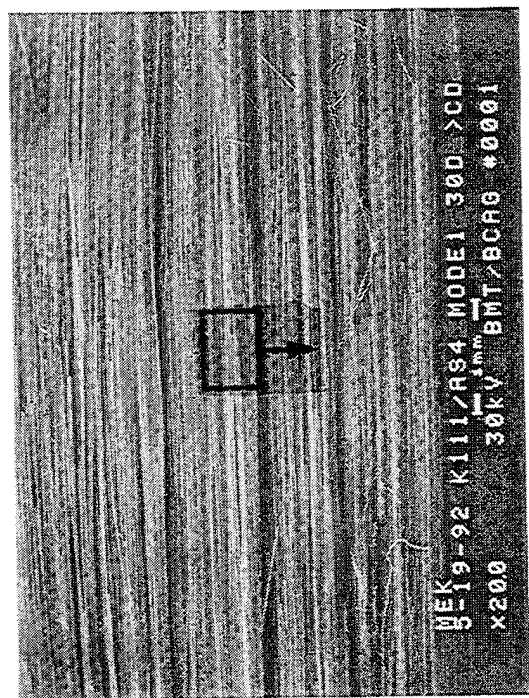
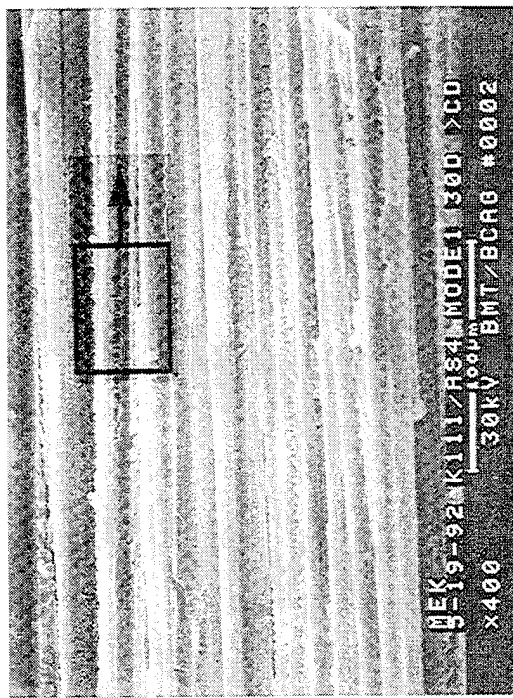
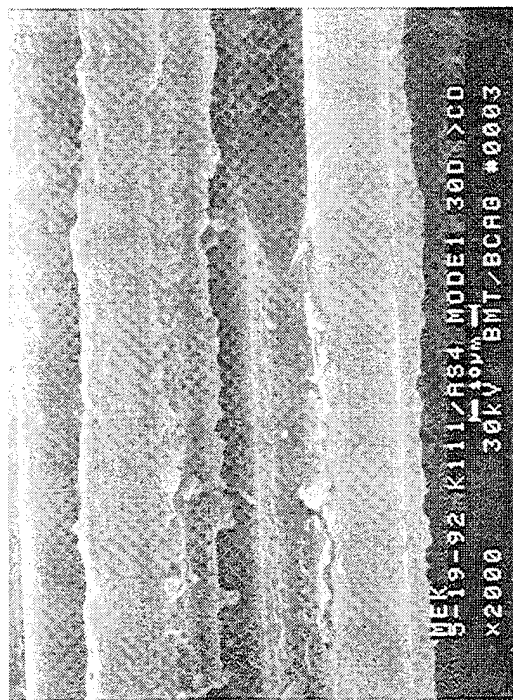
Figure 3.2-29. SEM Fractographs of a K111/AS4 Interlaminar Mode I Tension Fracture Surface Exposed to MEK for 24 Hours

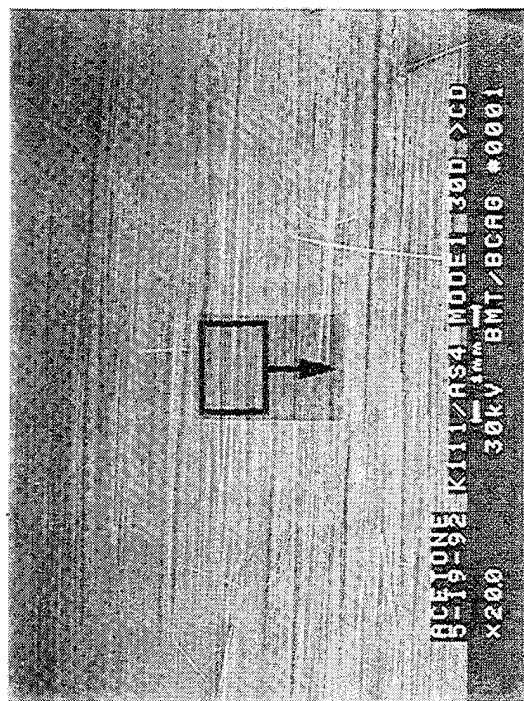
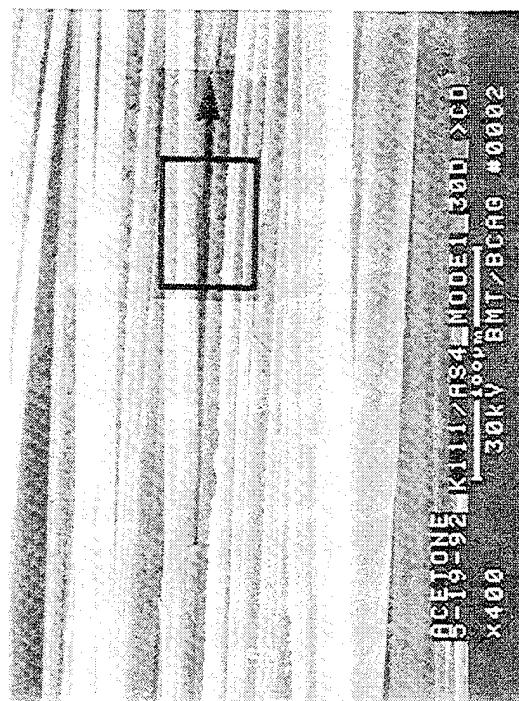
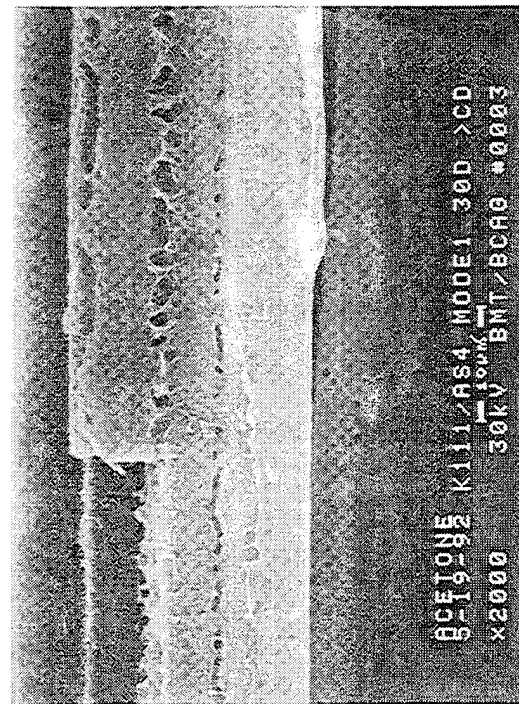
Figure 3.2-30. SEM Fractographs of a K111/AS4 Interlaminar Mode I Tension Fracture Surface Exposed to Acetone for 24 hours

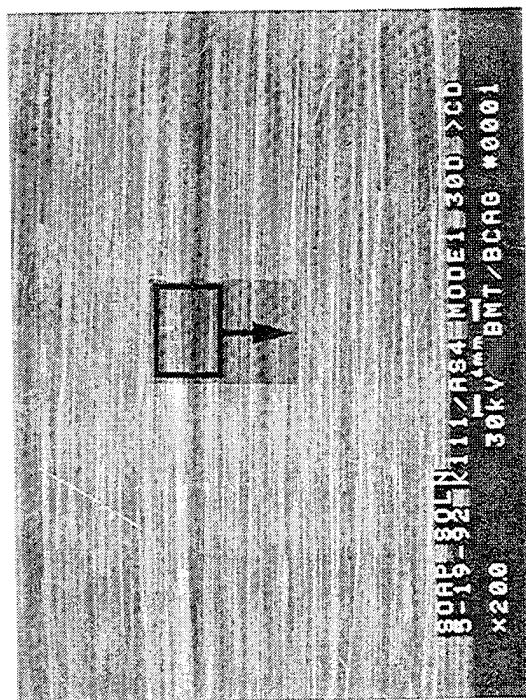
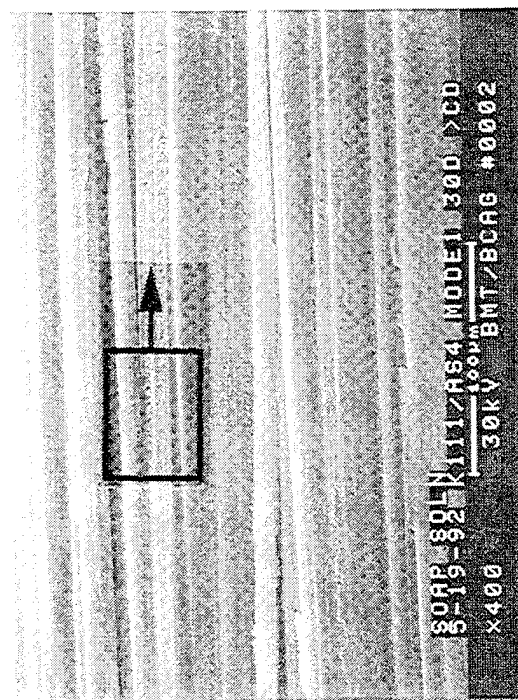
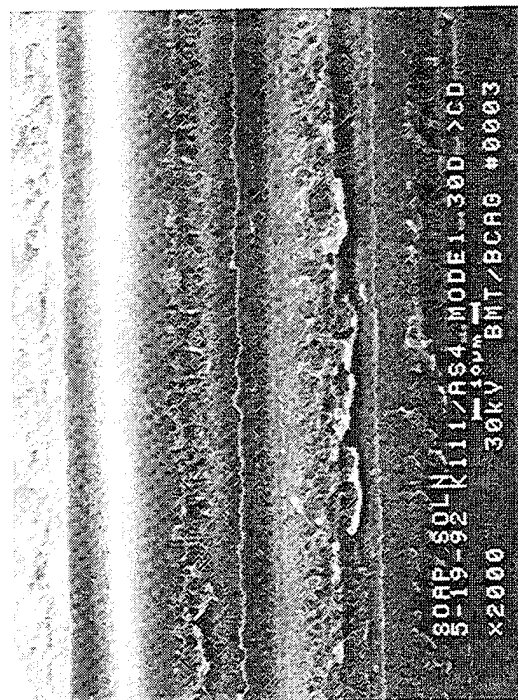
Figure 3.2-31. SEM Fractographs of a K111/AS4 Interlaminar Mode I Tension Fracture Surface Exposed to Soap Solution for 24 hours

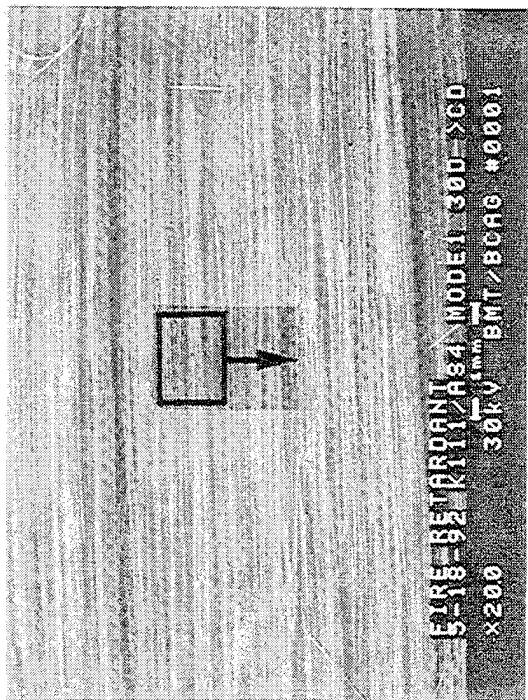
Figure 3.2-32. SEM Fractographs of a K111/AS4 Interlaminar Mode I Tension Fracture Surface Exposed to Fire Retardant Foam for 7 Days

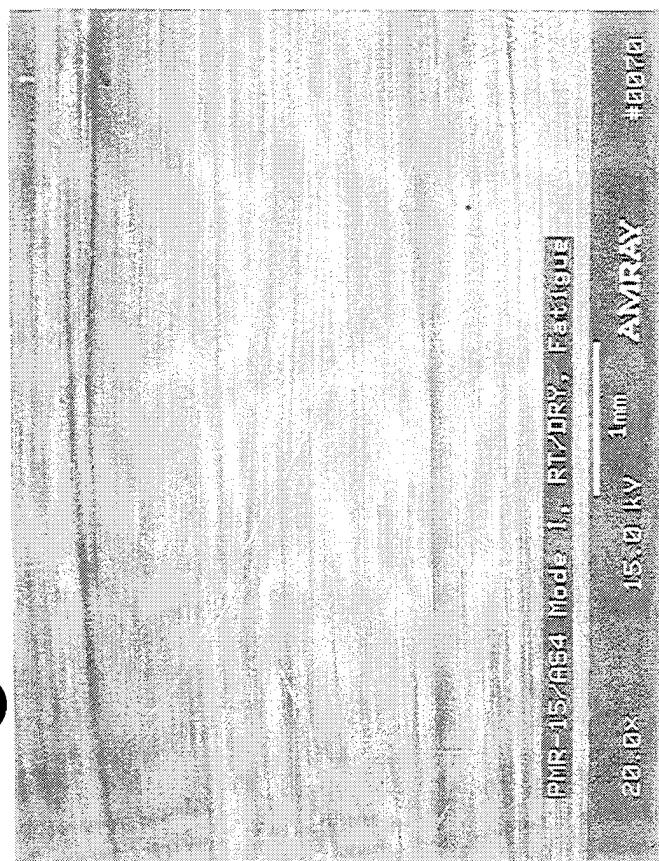
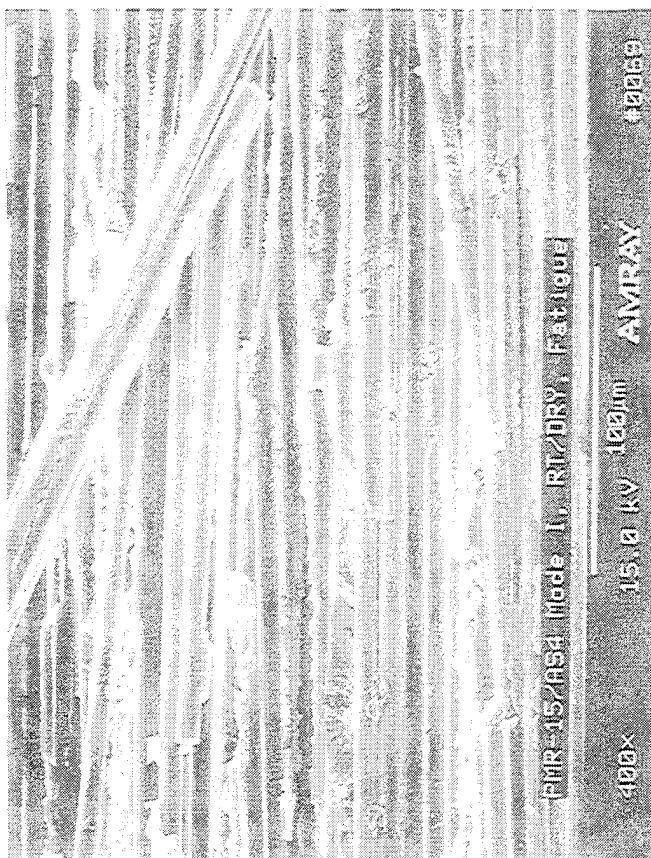
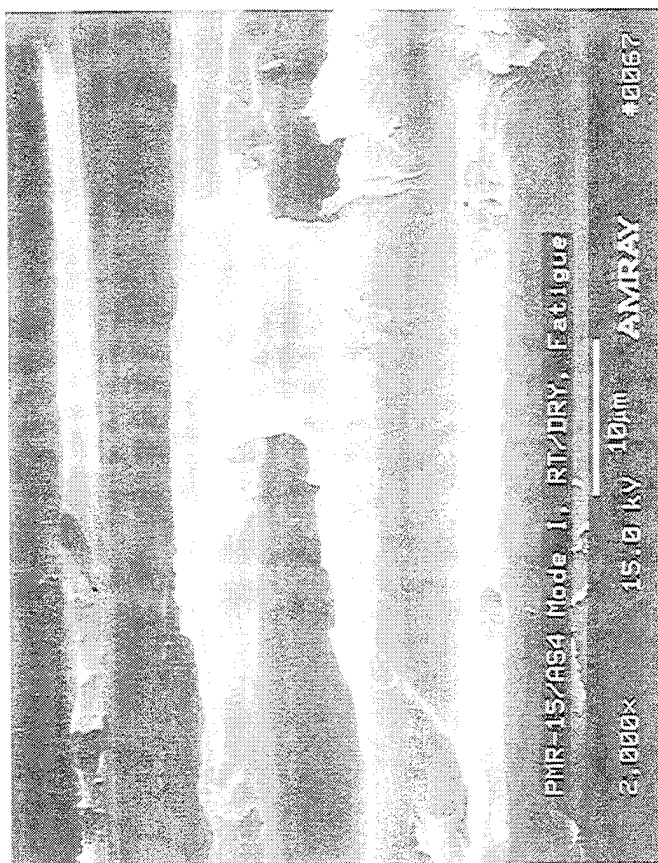
Figure 3.3-1. SEM Fractographs of a PMR-15/AS4 Interlaminar Mode I Tension Fatigue Fracture Surface, RT/Dry

The overall surface morphology exhibited similar features as the fracture surface of a statically loaded specimen (Figure 3.3-1). Rivermarks and hackles were observed including fatigue striations. However, the striation features, which were usually located in fiber pull out troughs, were very difficult to identify even at very high magnifications (Figure 3.3-2a). These striations were also observed in resin rich regions, which resembled typical "beach marks" in fatigued metals (Figure 3.3-2b).

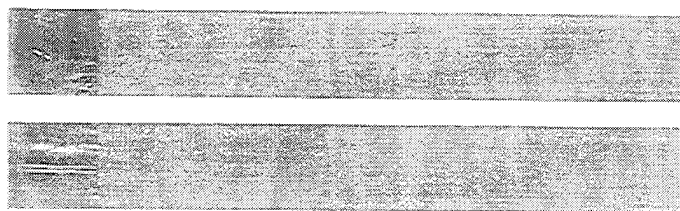
Figure 3.3-3. Optical Fractographs of a PMR-15/AS4 Interlaminar Mode I (Tensile) Fatigue Fracture Surface, 350° F

However the 350°F specimen fracture surface did not exhibit the typical mode I (tension) features. The fracture features were not distinct enough to determine the overall crack propagation direction

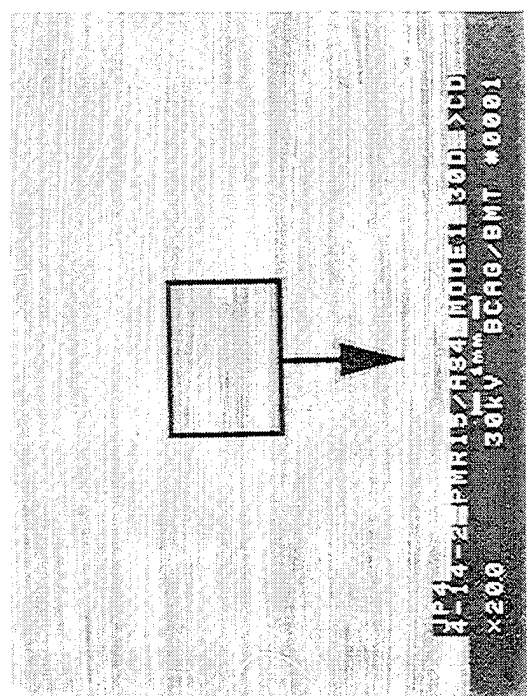
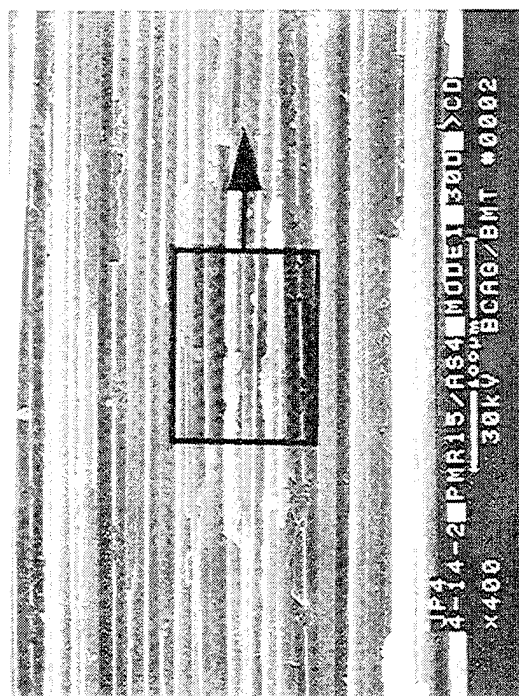
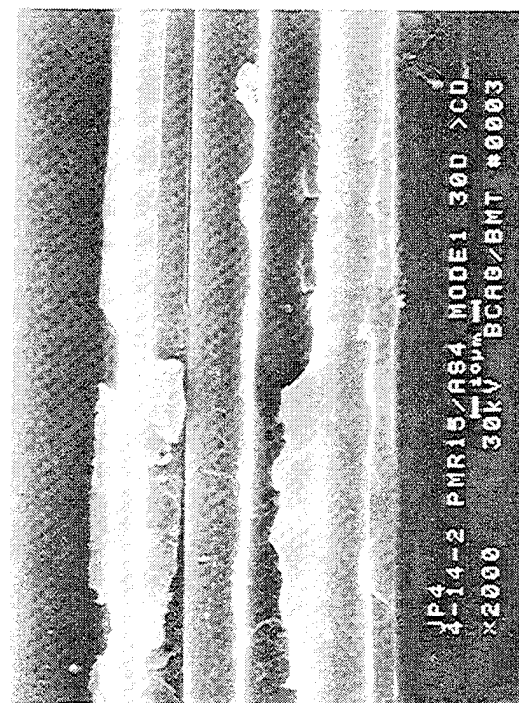
Figure 3.3-9. SEM Fractographs of a PMR-15/AS4 Interlaminar Mode I Tension Fracture Surface Exposed to JP4 Jet Fuel for 7 Days

The effects of the exposure did not affect the fracture morphology to any noticeable degree. All of the characteristic mode I surface features were easily identified (Figure 3.3-9 through 3.3-15).

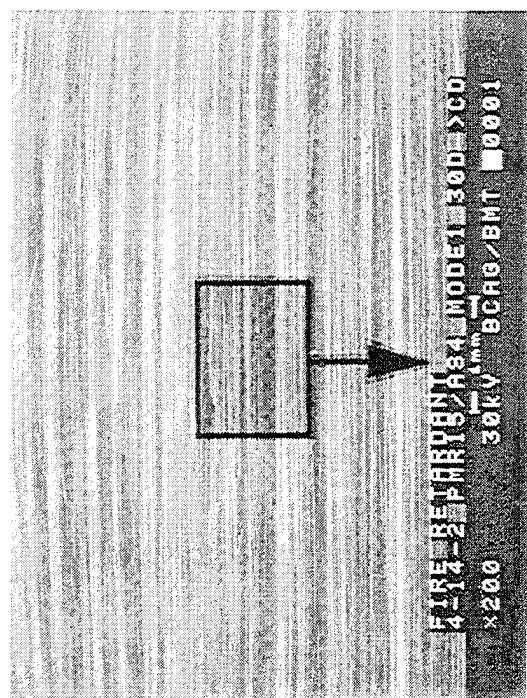
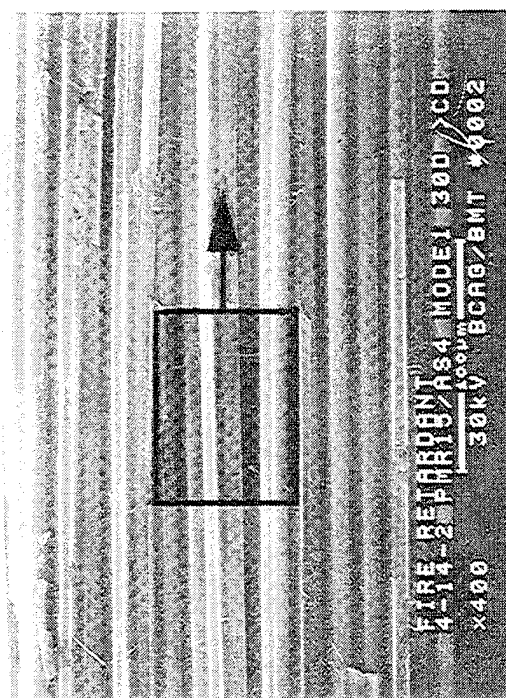
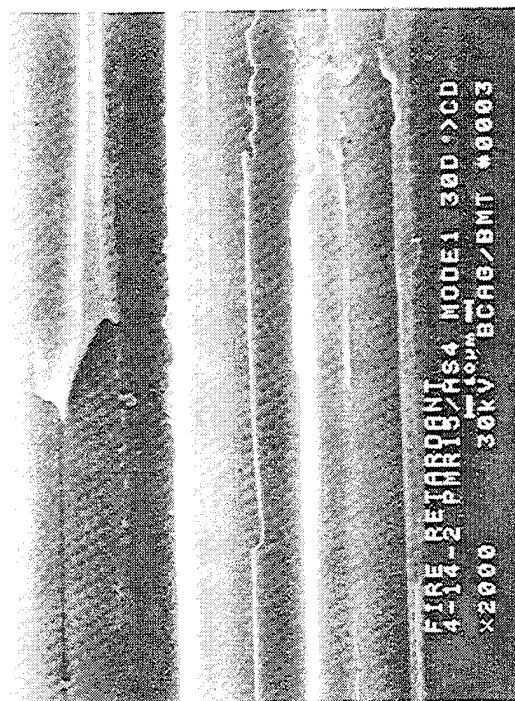
Figure 3.3-15. SEM Fractographs of a PMR-15/AS4 Interlaminar Mode I Tension Fracture Surface Exposed to Fire Retardant Foam for 7 Days

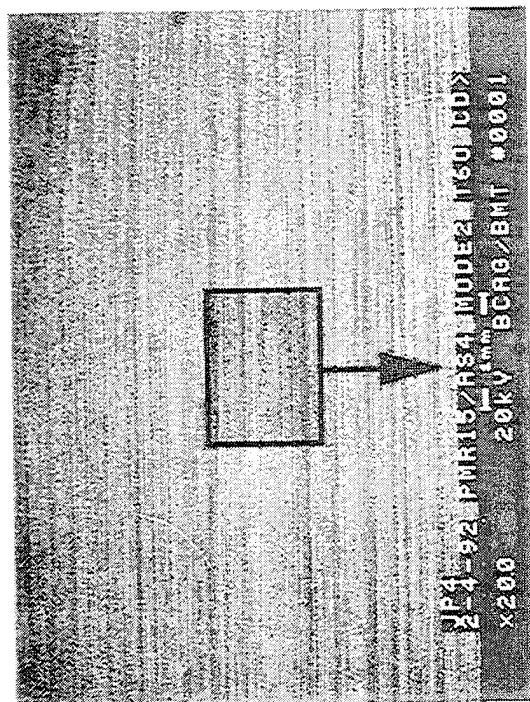
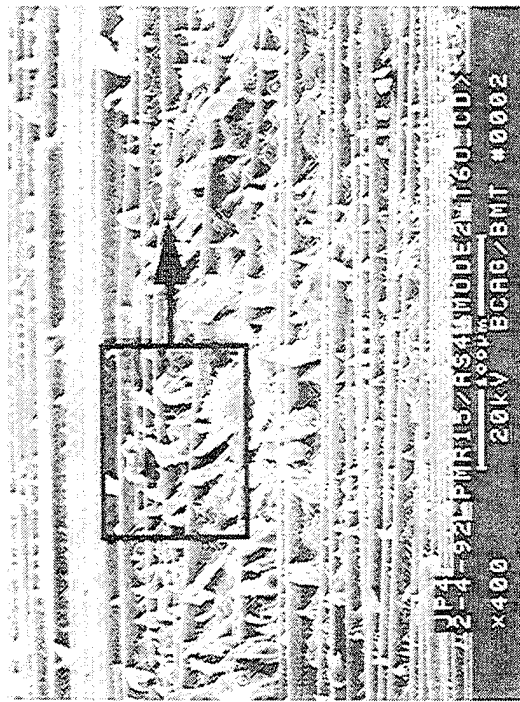
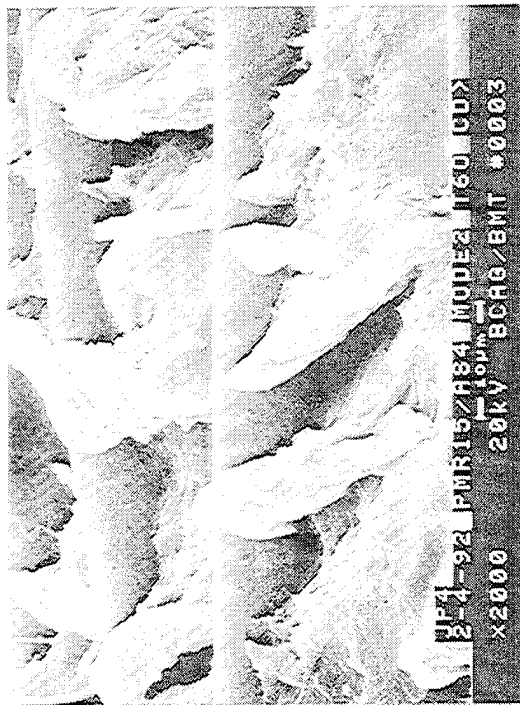
Figure 3.3-16. SEM Fractographs of a PMR-15/AS4 Interlaminar Mode II Shear Fracture Surface Exposed to JP4 Jet Fuel for 7 Days

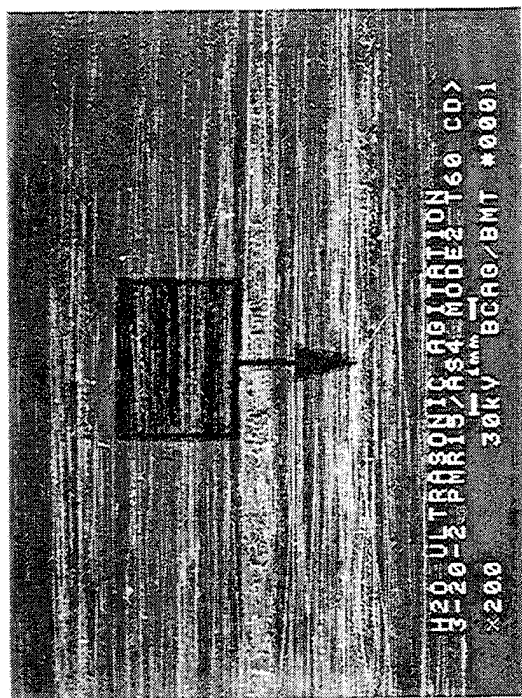
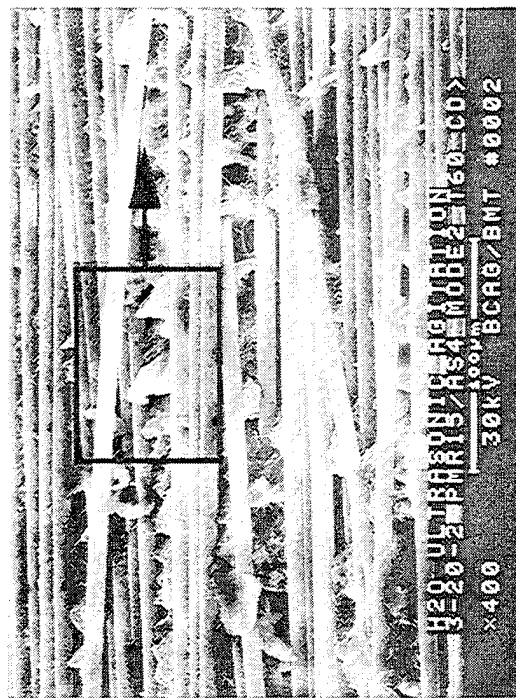
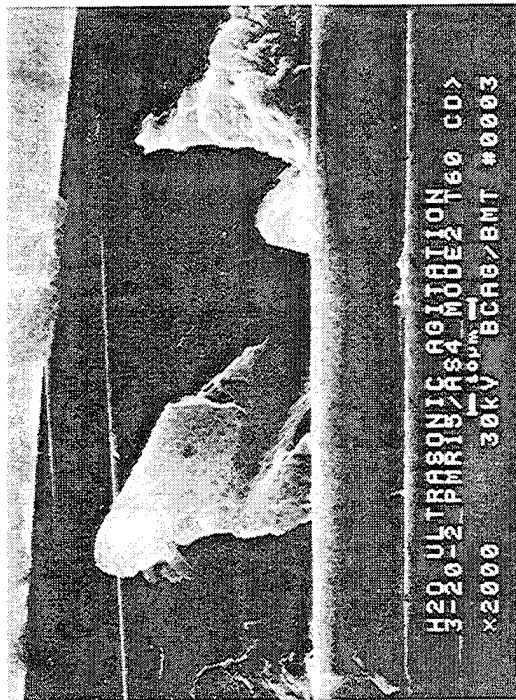
Figure 3.3-17. SEM Fractographs of a PMR-15/AS4 Interlaminar Mode II Shear Fracture Surface Exposed to Ultrasonic Agitation in Distilled Water for 24 hours
